FINAL REPORT

Texas High School Coastal Monitoring Program: 2017–2018

Ball, High Island, Palacios, Port Aransas,
Port Isabel, Van Vleck High Schools
and Cunningham Middle School

Report to the Texas Coastal Coordination Council pursuant to
National Oceanic and Atmospheric Administration Award No. NA16NOS4190174

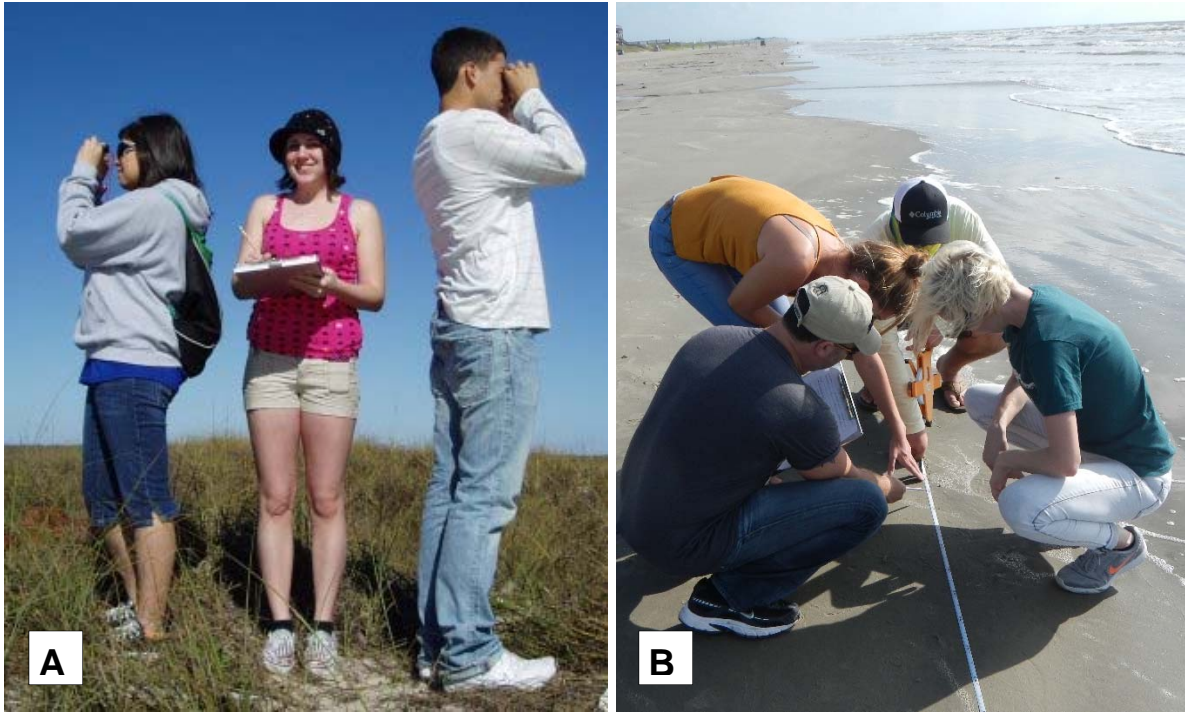
Figure 4. Students (A) using a sighting compass to measure dune orientation, and (B) measuring how far along the shoreline the float (an orange) drifted to determine longshore current.

(3) *Beach processes (fig. 4).* Students measure wind speed and direction, estimate the width of the surf zone, and observe breaker type. They note wave direction, height, and period and estimate longshore current speed and direction using a float, stopwatch, and tape measure. Students also take readings of shoreline and foredune orientation. From these measurements, they can infer relationships between physical processes and beach changes in time and space. Students also learn to obtain weather and oceanographic data from resources on the Internet.

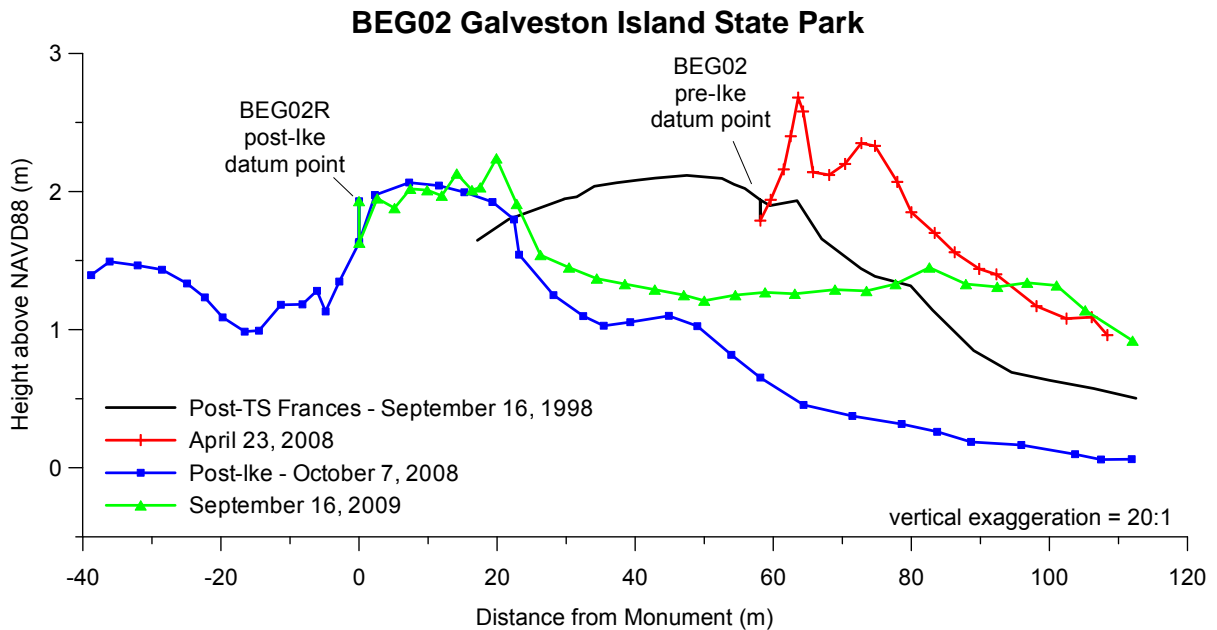
Figure 17. Beach-profile plots from BEG02 in Galveston Island State Park comparing the post–Hurricane Ike profile with a pre-storm profile from early 2008 and the post–Tropical Storm Frances profile from September 1998. Data from September 2009 (one year post-storm) is also included.

Ball High School students from the 2007–2008 academic year provided extremely valuable pre-storm profile data on February 8, 2008, and April 23, 2008. These data have been used to determine how much the beach and dunes changed after Hurricane Ike. **Figure 17** is a profile plot at BEG02 comparing the Ball High School pre-storm profile (April 2008) with the post–Hurricane Ike profile measured on October 7, 2008. The post–Tropical Storm Frances profile from September 16, 1998, is also plotted for comparison. At Galveston Island State Park the dune system was completely destroyed; the shoreline (wet beach/dry beach boundary) moved 53 m landward between April 23, 2008, and October 7, 2008; the vegetation line moved 56 m landward; and the old datum point was 1.14 m above the post-storm surface of the beach (**fig. 17**, Caudle and Paine, 2017). Data from one year post-storm is also included. This profile shows that the elevation of the beach had been restored, the beach width (dunes to waterline) has increased, and incipient dunes are beginning to form (**fig. 17**).
